Comparison of Electromagnetic and Natural Potential Geophysical Investigations near the Emperious Tailings Pile Creede, Colorado

Willow Creek Reclamation Committee

January 26, 2004

Agro Engineering, Inc.

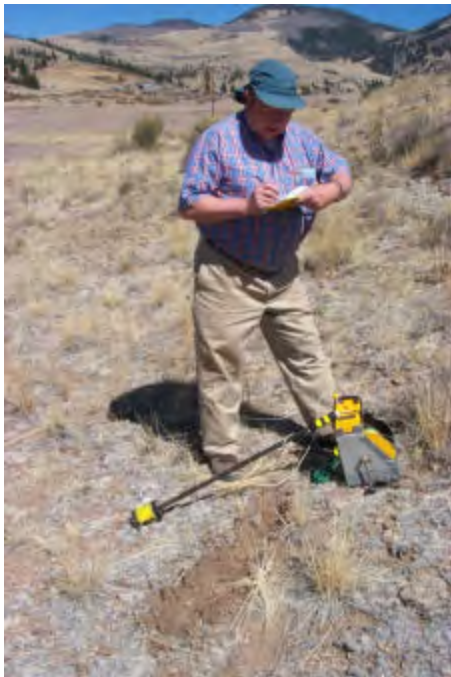
Above: Electromagnetic Method Investigation

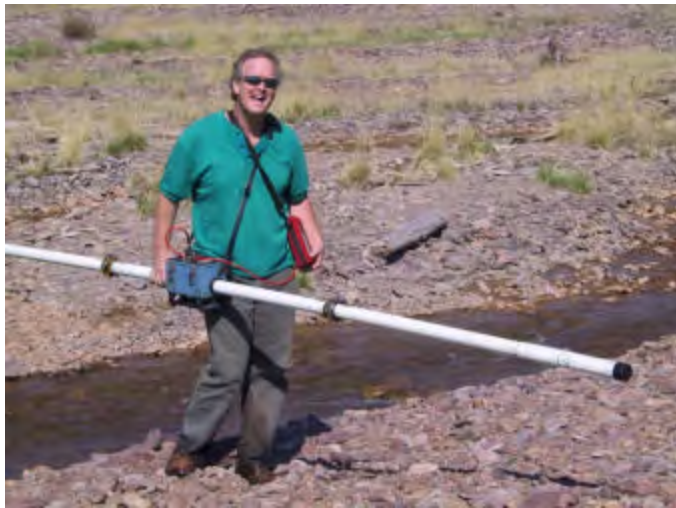
Left: Natural Potential Method Investigation
